HYBRID COMPOSITE RESPONSE TO HYDRAULIC RAM

Interim Report

THE JOINT LOGISTICS COMMANDERS
JOINT TECHNICAL COORDINATING GROUP
ON
AIRCRAFT SURVIVABILITY

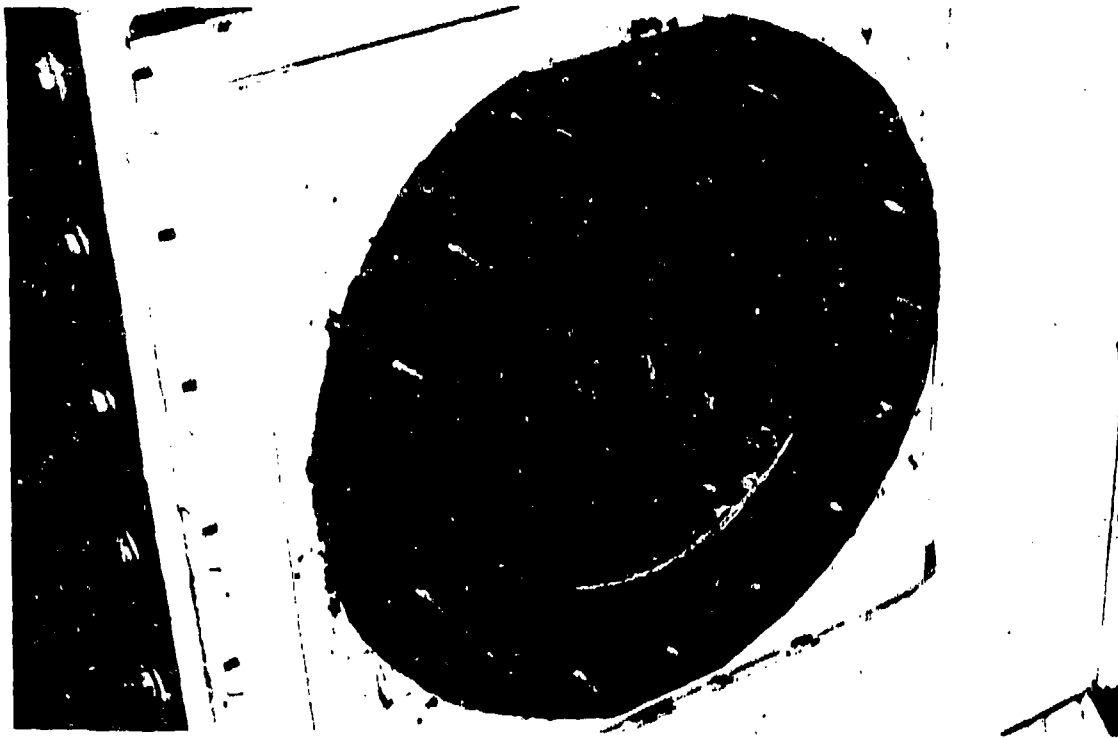
FIGURE 1. Hydraulic Ram Simulator Tank.

The test apparatus shown in Figures 1 through 5 was used to simulate hydraulic ram due to projectile penetration of a fuel tank. The hydraulic ram simulator tank is shown from the exit side in Figure 1. The steel and aluminum tank walls are 1/2 inch thick and 2 feet square. The tank has a free surface on the top and a 10-inch-diameter hole in the exit side. The 12-inch-diameter test panel is clamped over this opening with a 1/2-inch-thick steel ring, which in turn, is bolted to the exit wall. A 1-inch-wide ring around the outside of the panel is clamped, leaving a 10-inch-diameter area exposed on both sides. Figure 2 shows this ring being removed after a test shot. Note the chipped paint on the panel that outlines the area exposed to the hydraulic ram. The projectile enters the tank of water through a replaceable 1 1/2-inch rubber membrane. The entrance port is visible through the top of the tank in Figure 3 (rubber membrane is not in place). The round's velocity is determined by a timing trap located in front of the simulation tank (Figure 4) and is read out on a Hewlett-Packard 5328A universal counter. The gun is constructed so that the gases caused by firing are vented out of the barrel. Only the projectile enters the tank. Figure 5 shows the gun and the breach being assembled.

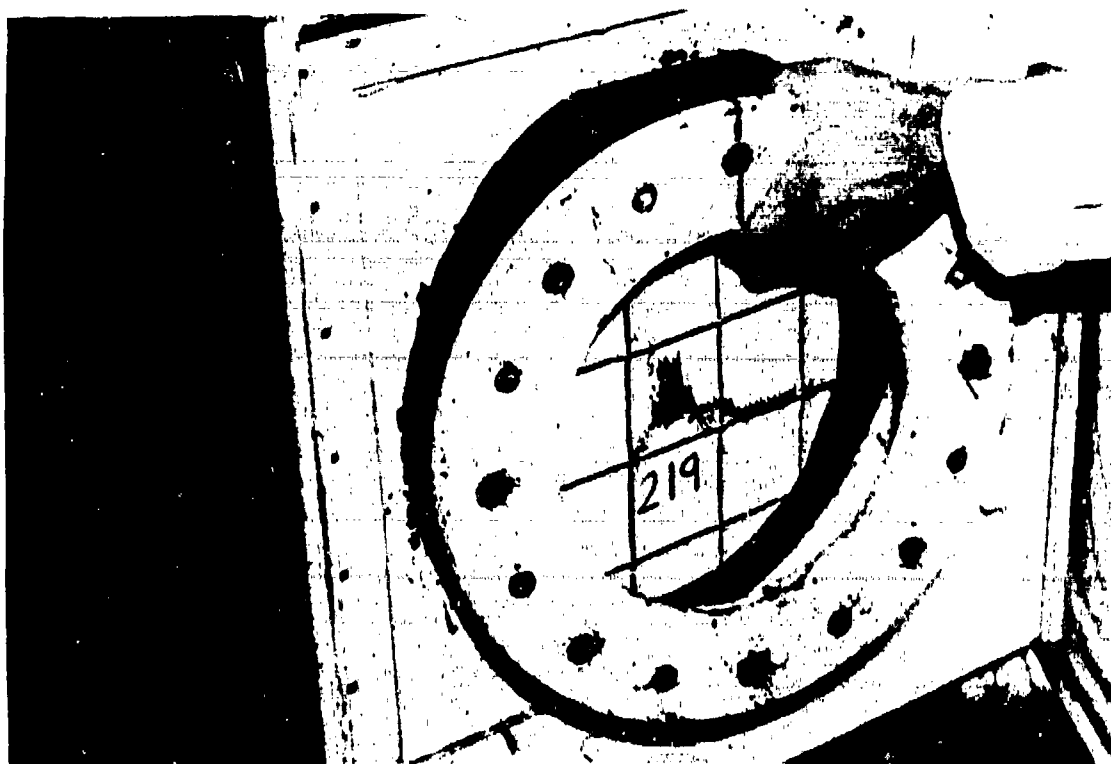
FIGURE 2. Clamping Ring.

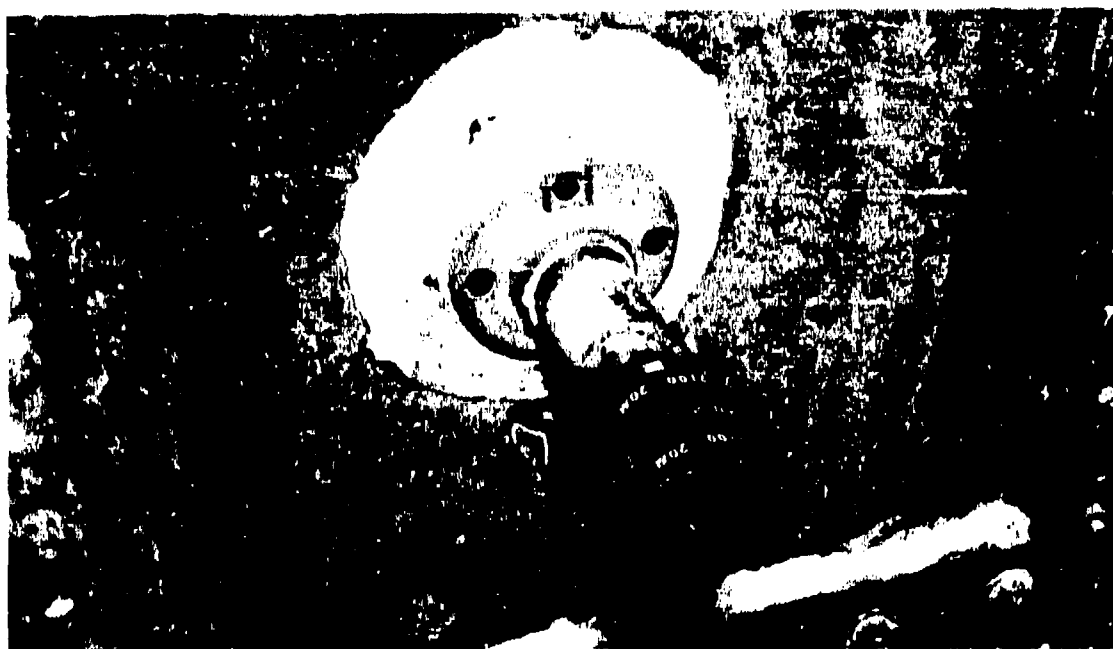
FIGURE 3. Simulator Tank Entrance Port.

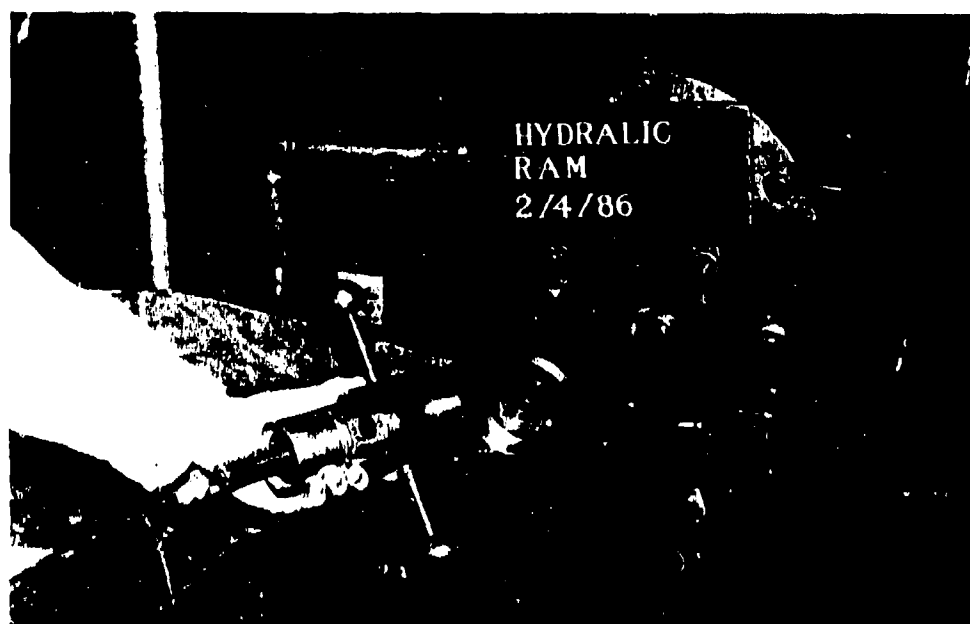
FIGURE 5. 50-Caliber Gun and Screw-in Breech.

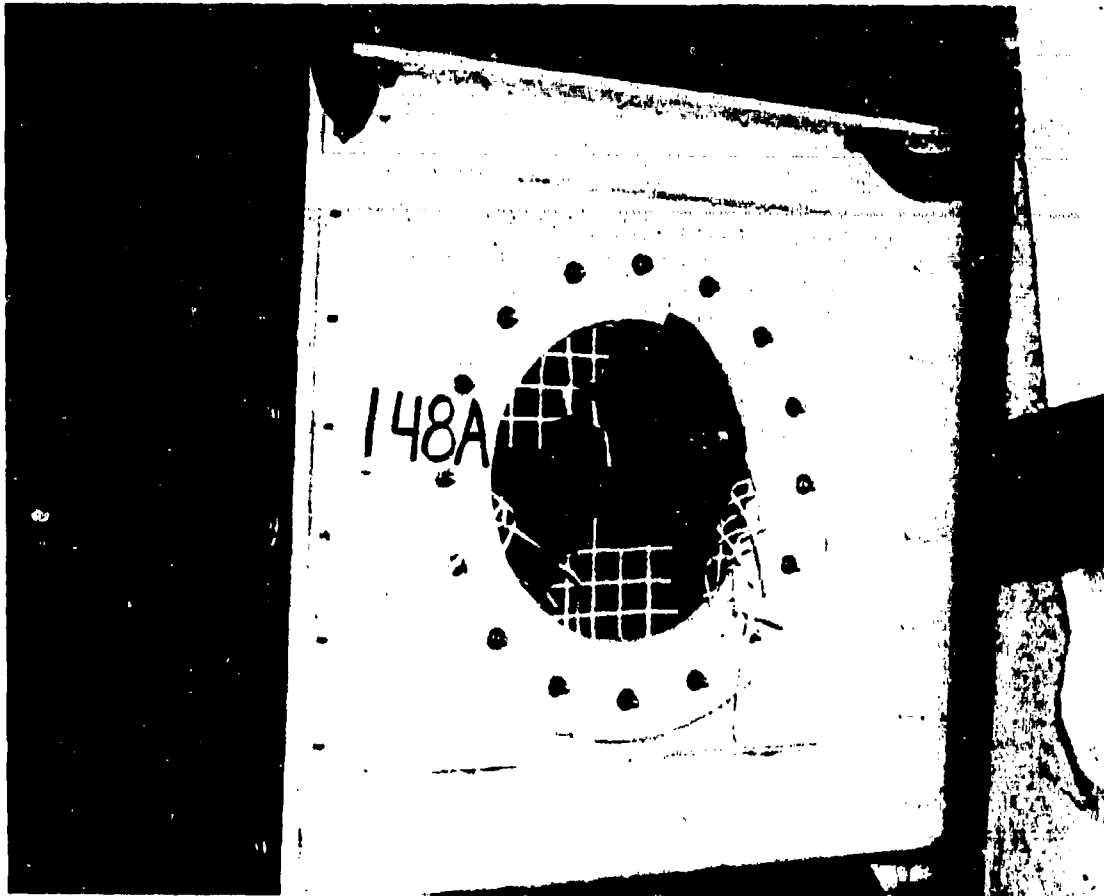
FIGURE 6. Damage Sustained by Baseline Graphite/Epoxy Panel From 1500-ft/sec Threat.

This baseline panel is composed of six layers of graphite cloth arranged 0-90/ \pm 45/0-90/ \pm 45/0-90/ \pm 45 in an epoxy matrix. Any concept showing damage equal to or greater than the plain composite panel was dropped from further testing. Figure 6 shows how the baseline panel brittly cracked out to and around the clamping ring. This is common in composites impacted by hydraulic ram. Figure 7 shows the damage caused by hydraulic ram to a 7075-T6 aluminum plate of approximately the same thickness as the composite panels. Notice the yielding of the plate in this more ductile material.

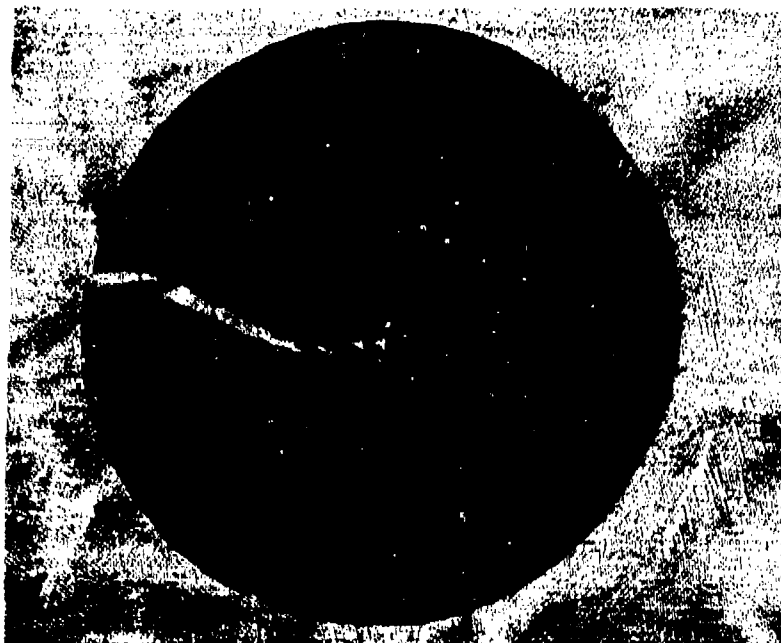
FIGURE 8. Damage Sustained by E-Glass Strip Grid Panel.

The 100 series tests eliminated several concepts from further testing. The electrical grade fiber glass (E-Glass) strip configuration panel failed (Figure 8), as did the panel with grids of hand braided E-Glass cord. Another concept that failed was a sandwich structure of self-vulcanizing rubber, in which a layer of rubber was glued between precured graphite layers (Figure 9). The adhesively bonded graphite stringer concept (Figure 10) was also eliminated. The adhesive bond between the stringers and the panel failed, which left essentially a baseline panel. Figure 11 shows the extent of the stringer separation from one of these panels. The Ryton thermoplastic panels produced by Phillips 66 were also drastic failures (Figures 12 and 13). The performance of all the panels tested in the 100 series is presented in Table 2.

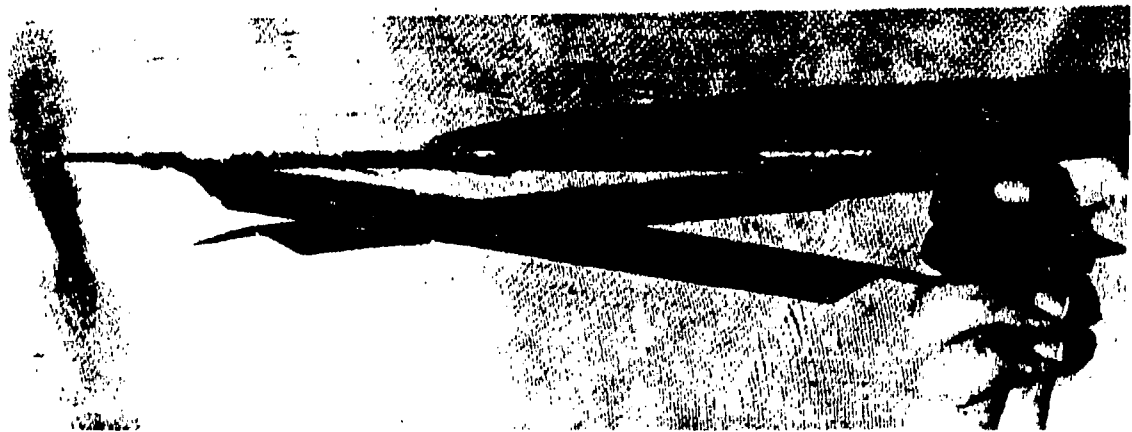
FIGURE 11. Stringers Debonded From Panel.

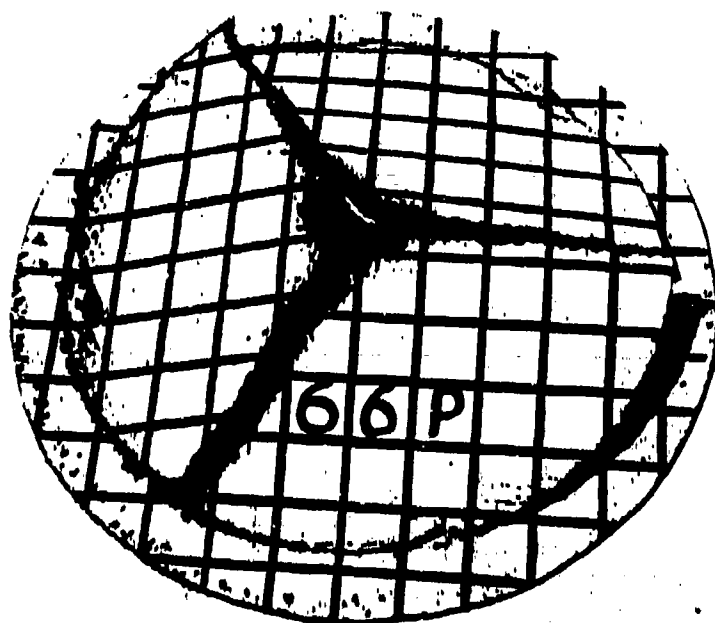
FIGURE 12. Damage Sustained by Ryton Thermoplastic Panel.

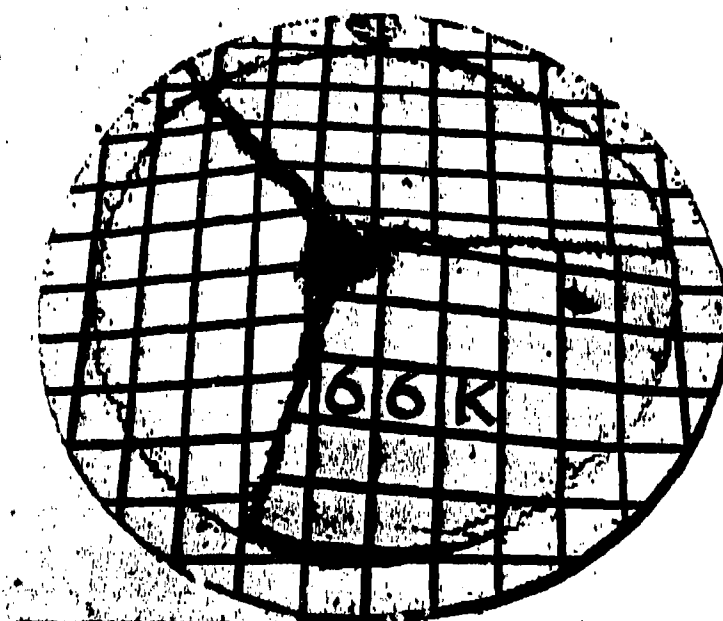
FIGURE 13. Damage Sustained by Ryton Thermoplastic Panel With Kevlar Layer.

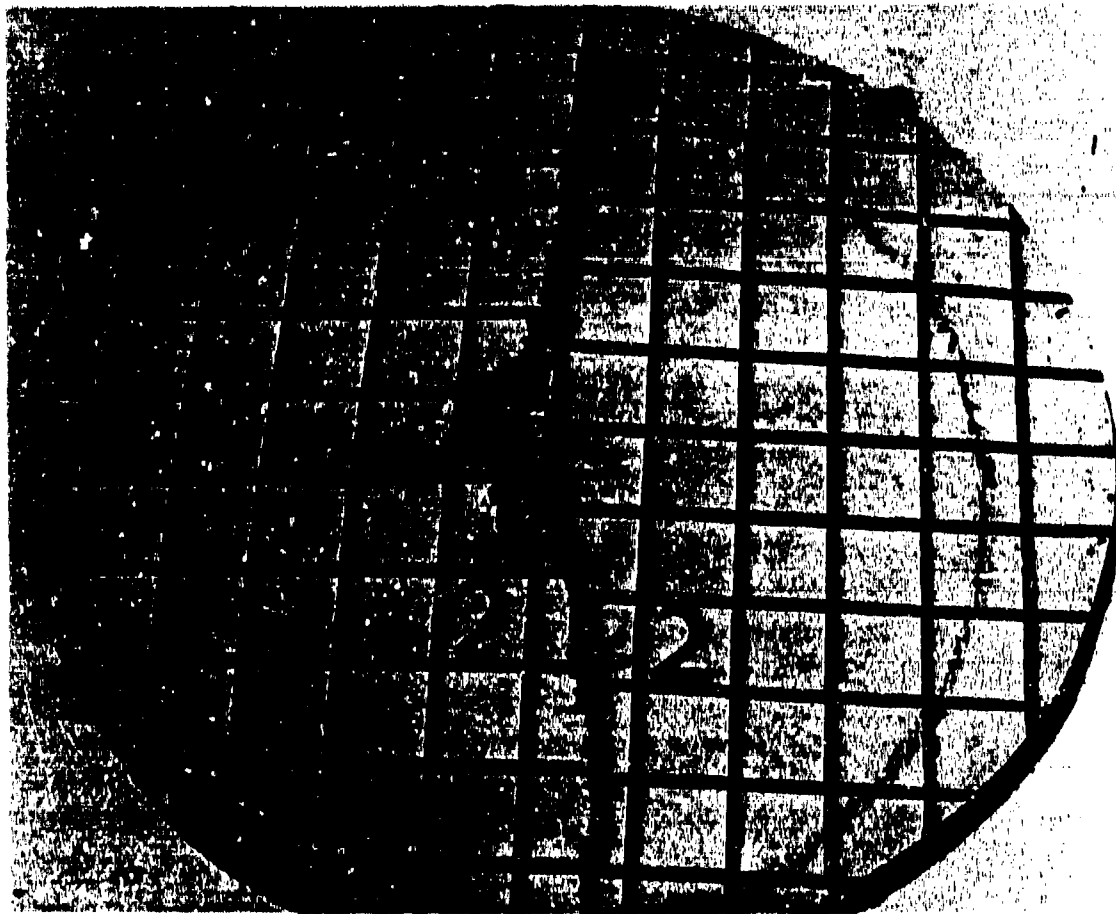
FIGURE 14. Damage Sustained by 200 Series Baseline Panel.

The 200 series tests were shot at a nominal 1900-ft/sec velocity. The 200 series tests provided a more serious threat to the concepts that survived the 100 series. The higher velocity was intended to cause more extensive damage to the panels so that the differences between the panels would be more apparent. Figure 14 shows the baseline graphite panel for the 200 series tests. This panel contains five layers of graphite cloth arranged 0-90/±45/0-90/±45/0-90.

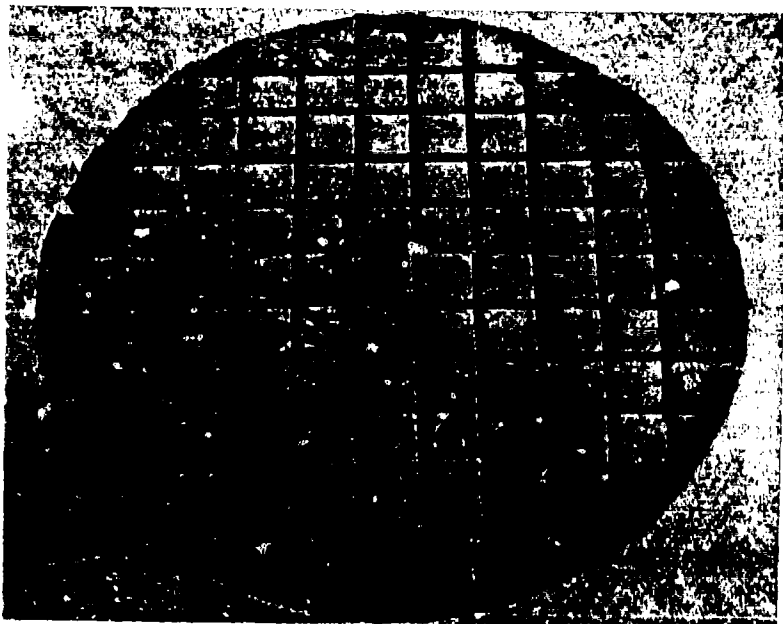
FIGURE 15. Damage Sustained by Kevlar Cord Grid Panel (Grids on 1-Inch Spacing).

As for the cord materials, Kevlar and Nylon appeared to achieve about the same survivability increase. Since Kevlar has a tensile strength many times higher than nylon, it appeared that the decrease in cord vulnerability was not related to ultimate strength. Neither cord broke, except when struck directly by the round, and both the Kevlar and Nylon experienced the same amount of delamination. Table 3 shows the results of each test. Table 4 shows the relative survivability of the most successful cord grid panels. Figures 15 through 18 show these panels in descending order, from least vulnerable to more vulnerable.

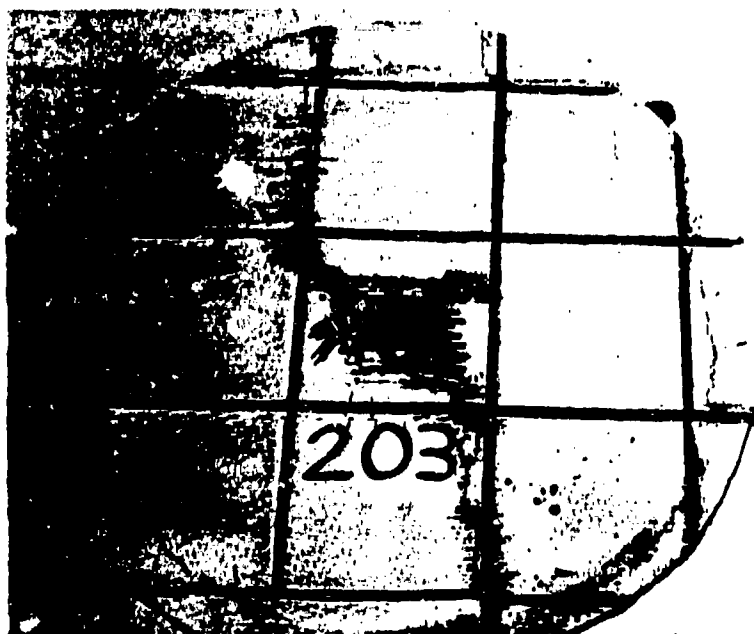
FIGURE 16. Damage Sustained by Kevlar Cord Grid Panel (Grids on 3-Inch Spacing).

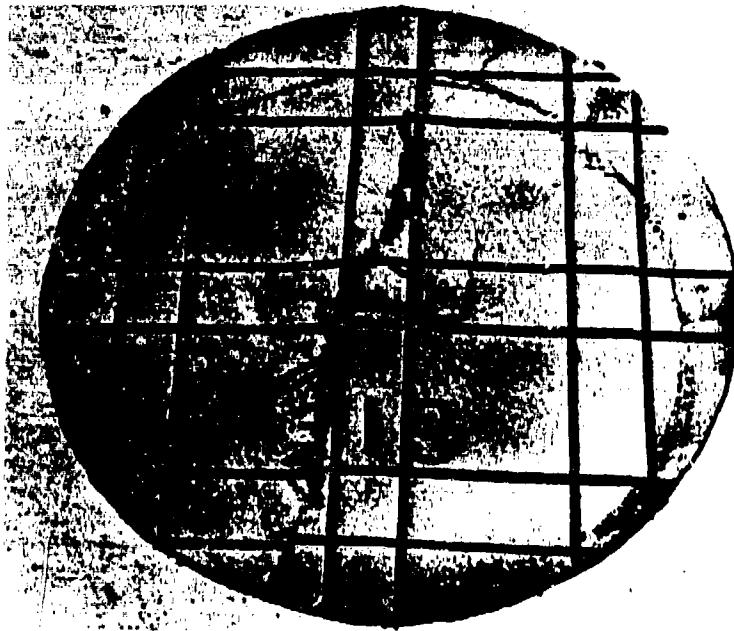
FIGURE 19. Damage Sustained by Spectra 1000 Strip Grid Panel.

Table 5 shows the results of each test. Table 6 shows the relative survivability of the most successful strip grid panels. Figures 19 through 21 show these panels in descending order, from least vulnerable to more vulnerable.

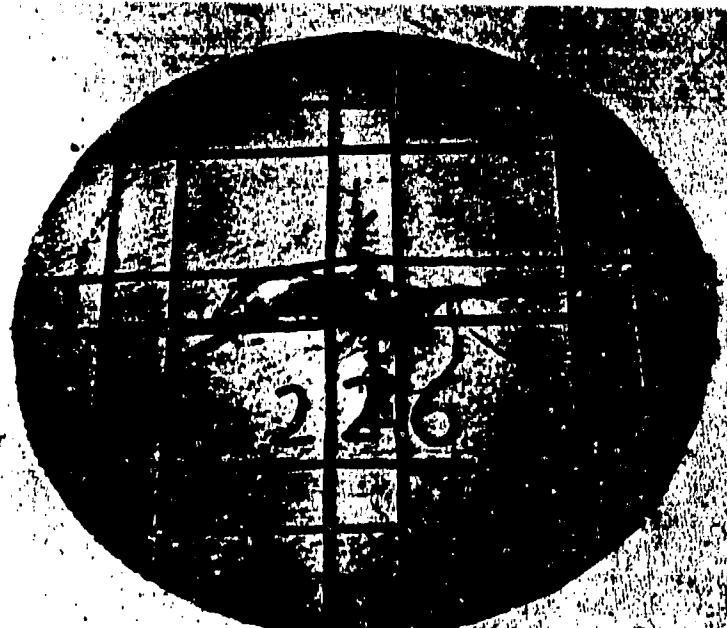
FIGURE 20. Damage Sustained by Kevlar Strip Grid Panel.

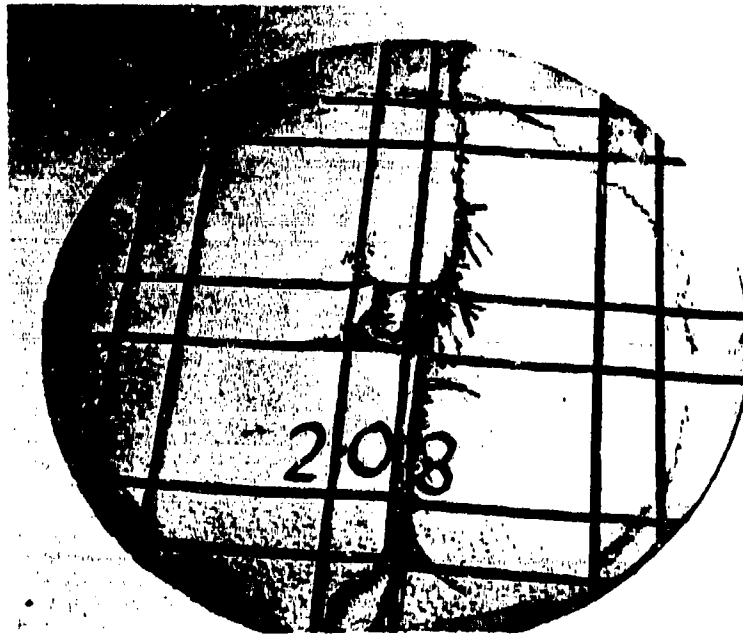
FIGURE 21. Damage Sustained by Spectra 900 Strip Grid Panel.

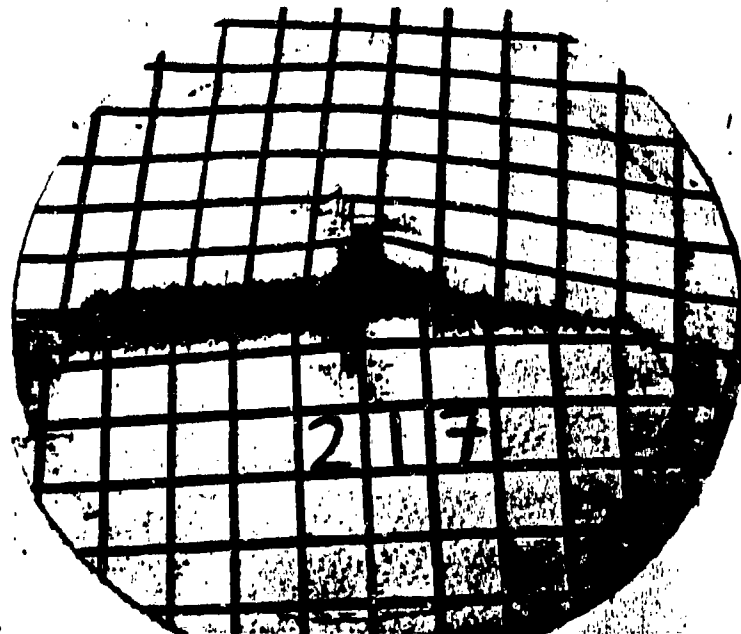
FIGURE 22. Damage Sustained by a Panel With 1/4-Inch of Foam Between Base Layers.

Layers. Adding complete layers of cloth or foam to the base graphite panel was the third structural configuration tested. The panels using a foam layer between base layers (panels 217 (Figure 22) and 218 (Figure 23)) broke into several pieces and were a drastic failure. Also considered a failure was panel 211, which had a layer of Kevlar and foam. This panel experienced severe cracking and had the ring clamp not been present, the layer of Kevlar would have completely delaminated (Figures 24 and 25). The use of foam within the composite layup is the least survivable layer concept. However, the use of foam as the first layer, next to the fluid, was effective. The idea behind this concept was that the hydraulic ram effect would be dissipated by crushing the foam. This concept, although quite effective in the 100 series testing (Figures 26 and 27), was considered too bulky for tactical aircraft, wasted fuel volume, and weighed nearly twice as much as other concepts showing the same increase in survivability; therefore, it was not included in the 200 series testing.

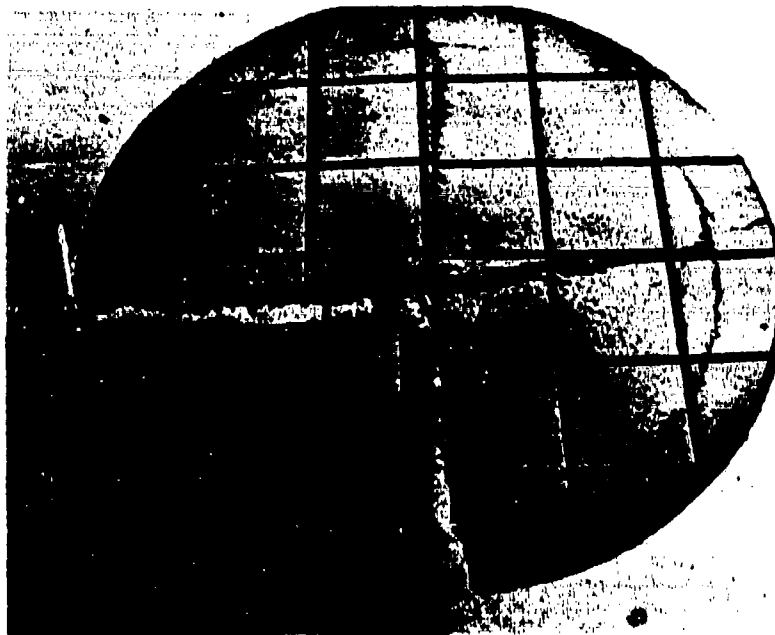
FIGURE 23. Damage Sustained by a Panel With 1/4-Inch of Foam Between Base Layers.

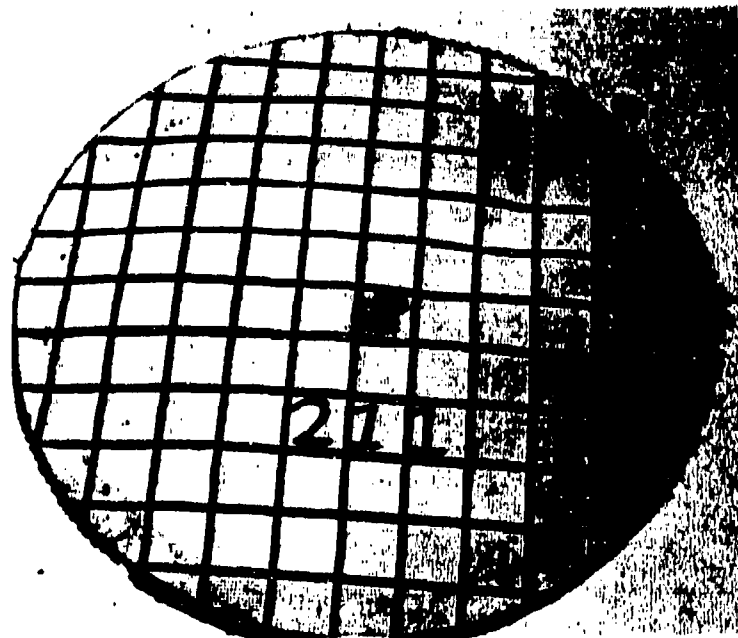
FIGURE 24. Damage Sustained by a Panel With 1/4-Inch of Foam Under a Layer of Kevlar.

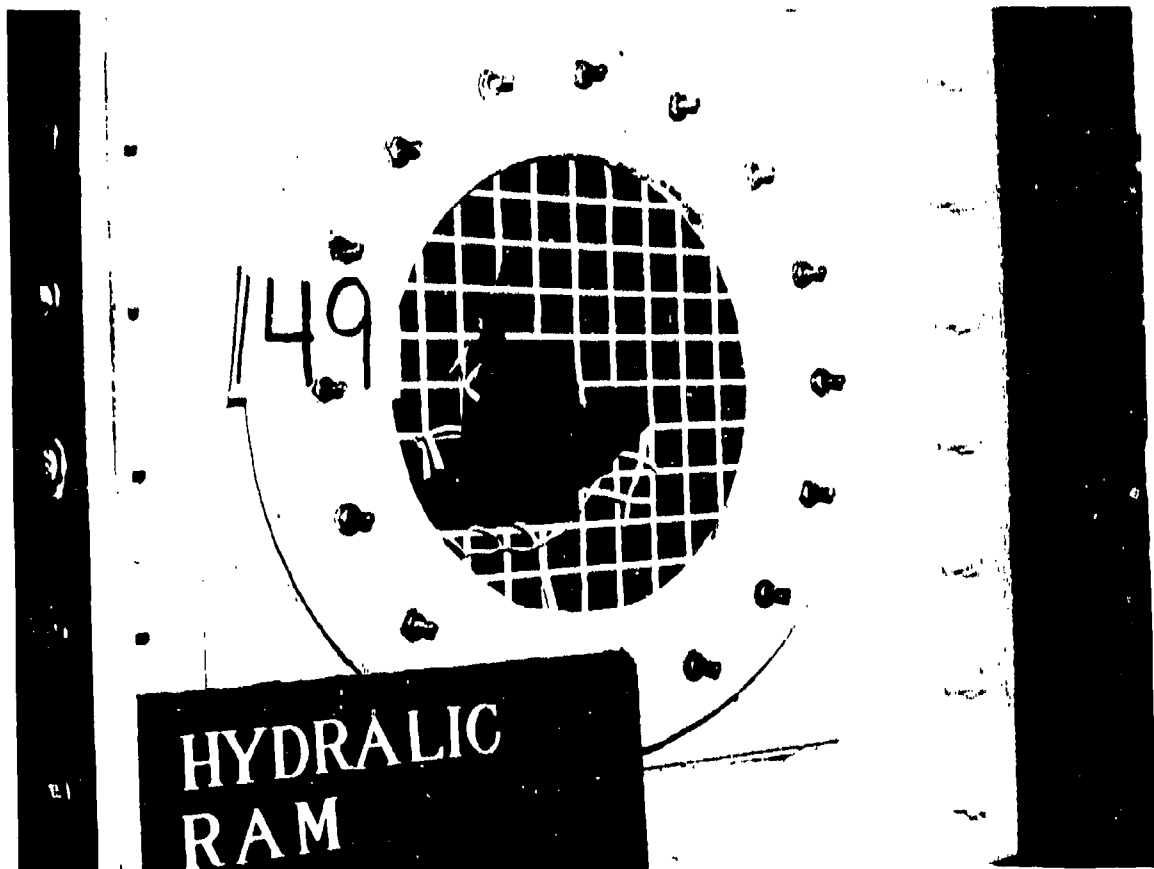
FIGURE 26. Damage Sustained in the 100 Series Testing by a Panel With 1/2-Inch of Foam on the Impact Face.

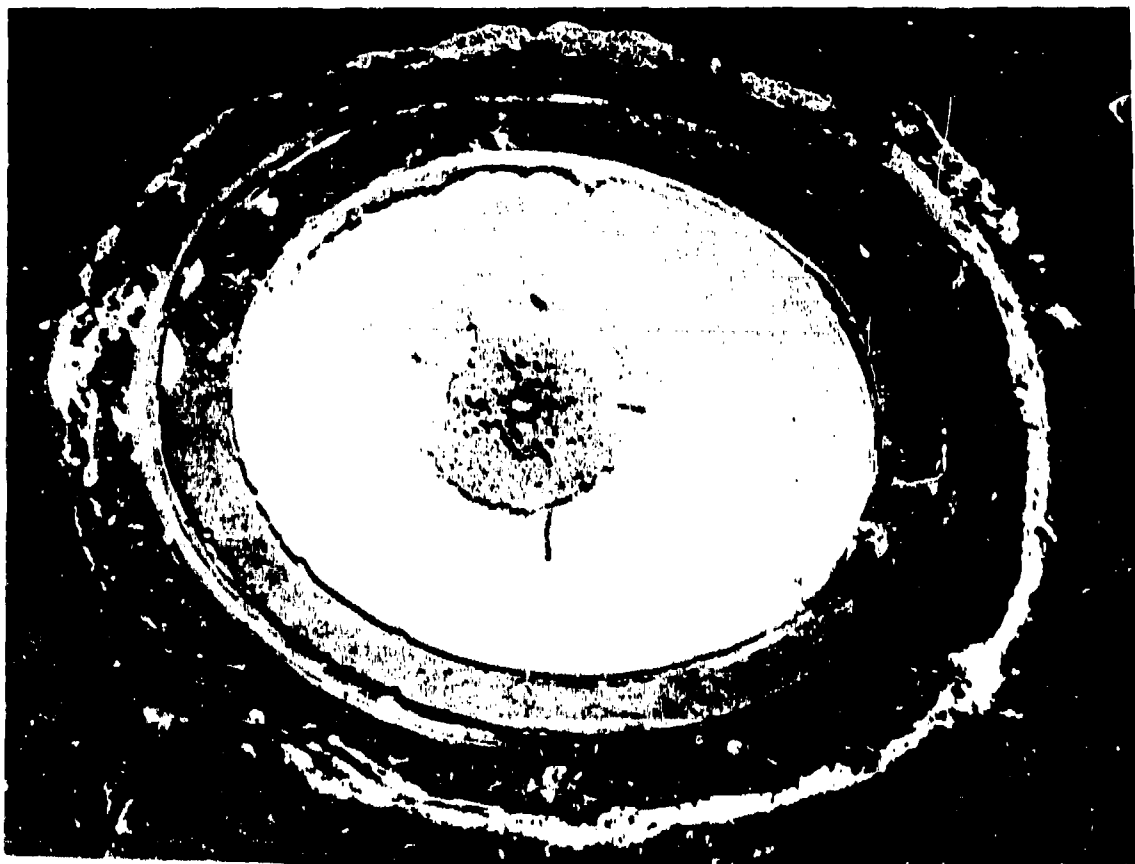
FIGURE 27. Damage Sustained in the 100 Series Testing By a Panel With 1/2-Inch of Foam on the Impact Face.

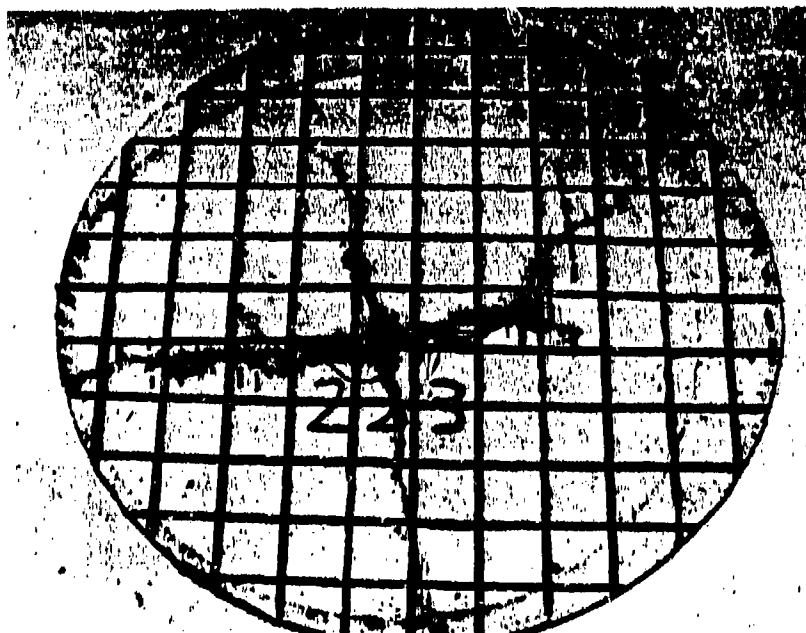
FIGURE 30. Damage Sustained by Spectra 1000 Layer Panel (Spectra Layer Inside).

Table 7 shows the results of each test. Table 8 shows the relative survivability of the most successful layer panels. Figures 28 through 32 show these panels from least vulnerable to more vulnerable.

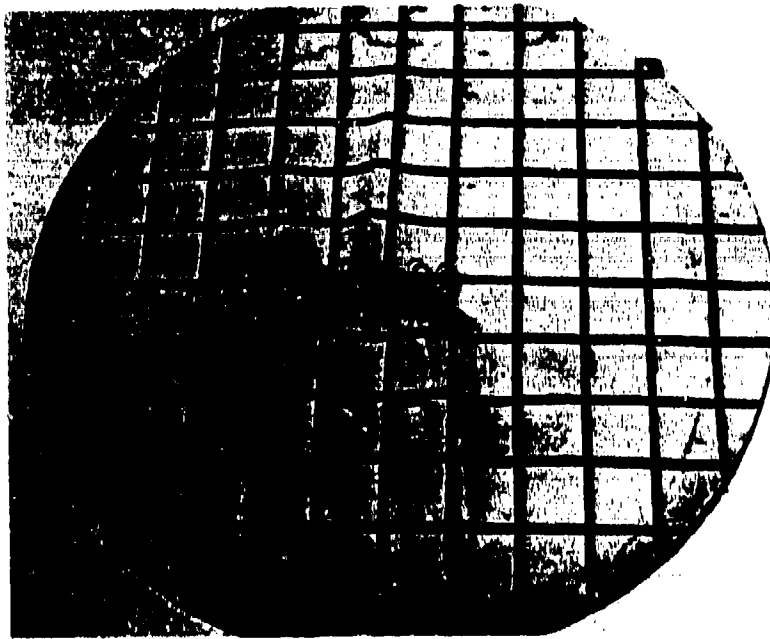
FIGURE 31. Damage Sustained by Spectra 1000 Layer Panel (Spectra Layer Outside).

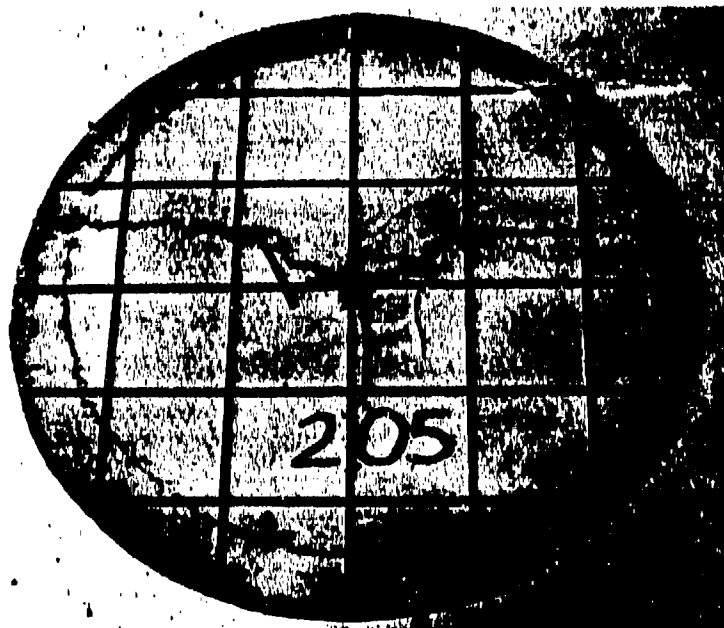
FIGURE 32. Damage Sustained by Spectra 900 Layer Panel (Spectra Layer Inside).

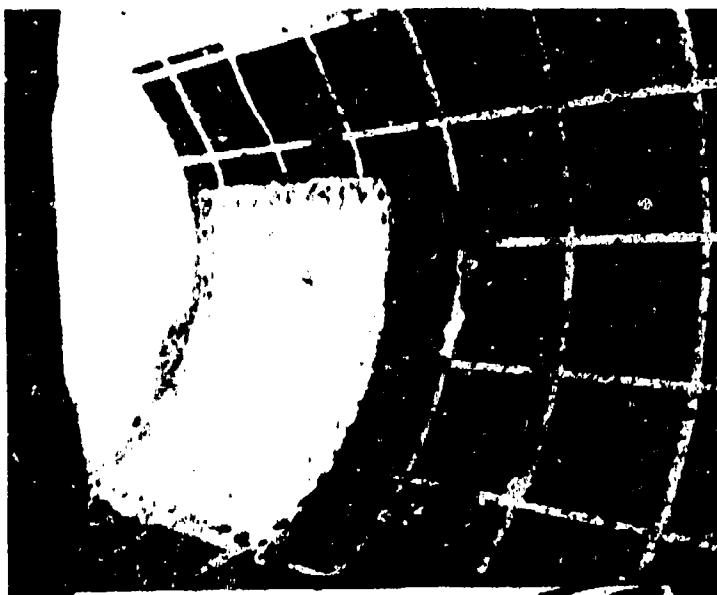
(a)

FIGURE 34. High-Speed Film of Hydraulic Ram Damage Occuring.

The second shot at the baseline panel also veered appreciably from its expected trajectory, striking the panel very near the edge. The damage to the panel was fairly extensive. The panel cracked and buckled at the point of impact (Figure 34). Most of the bolts either pulled through the panel or sheared off. The panel delaminated only slightly. The extent of the cracking was rated as severe, extending more than 8 inches from the point of impact (Figure 35). Delamination was rated minor.

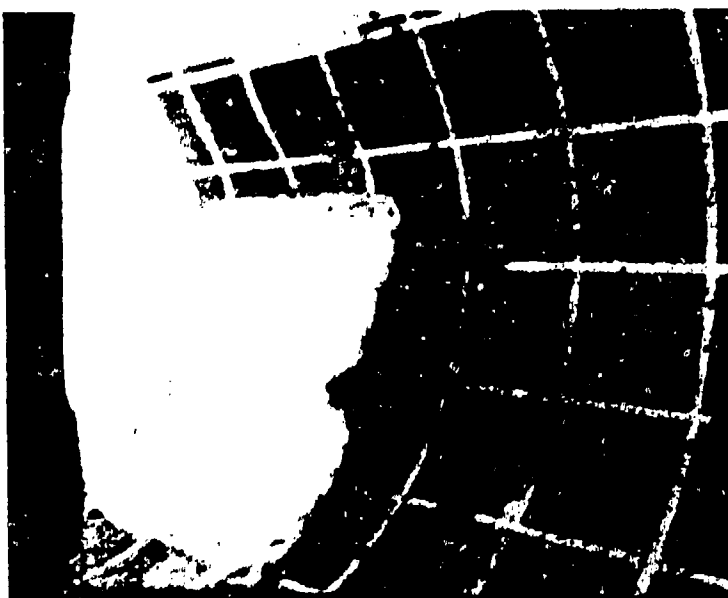
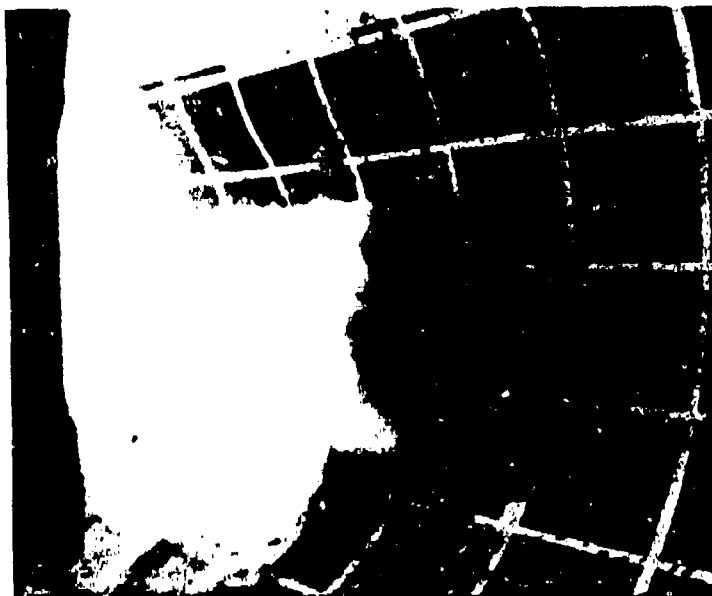
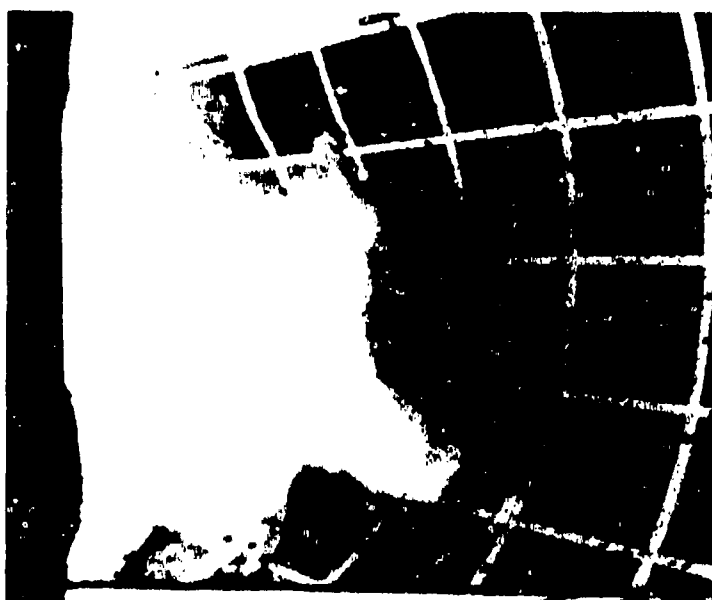
FIGURE 34. (Contd.)

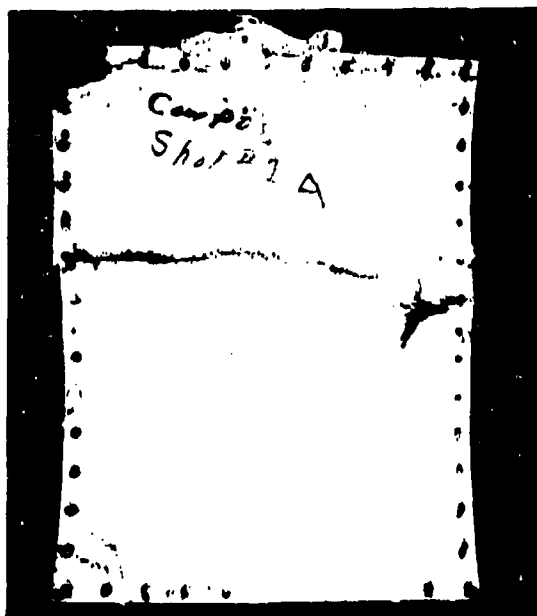
FIGURE 35. Damage Sustained by
Baseline Panel Subjected to Hydraulic
Ram From 14.5-mm API Round.

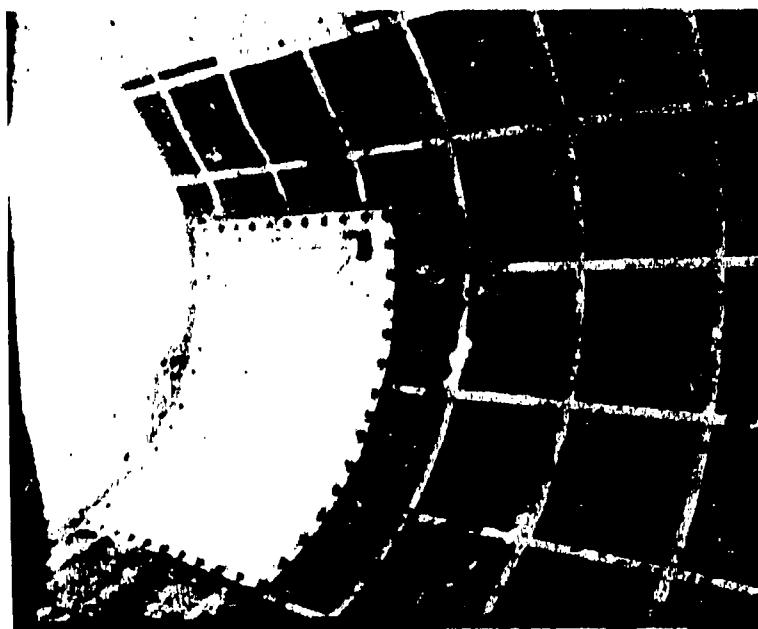
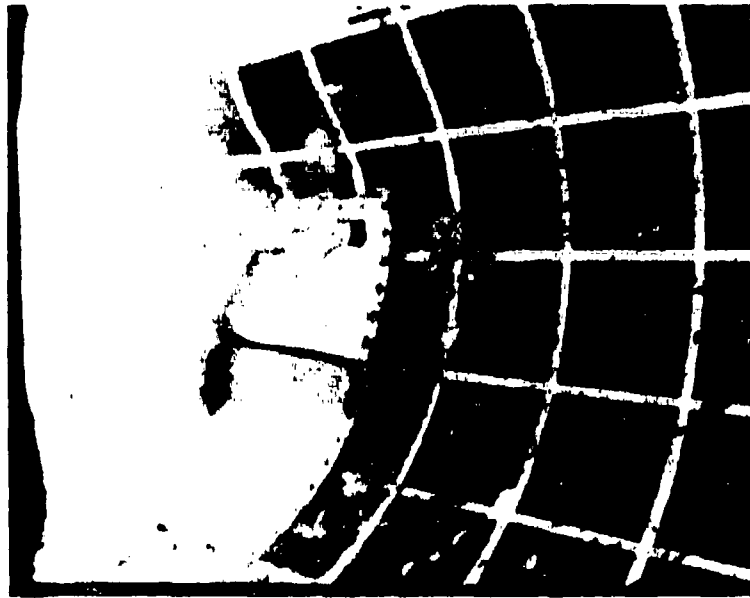
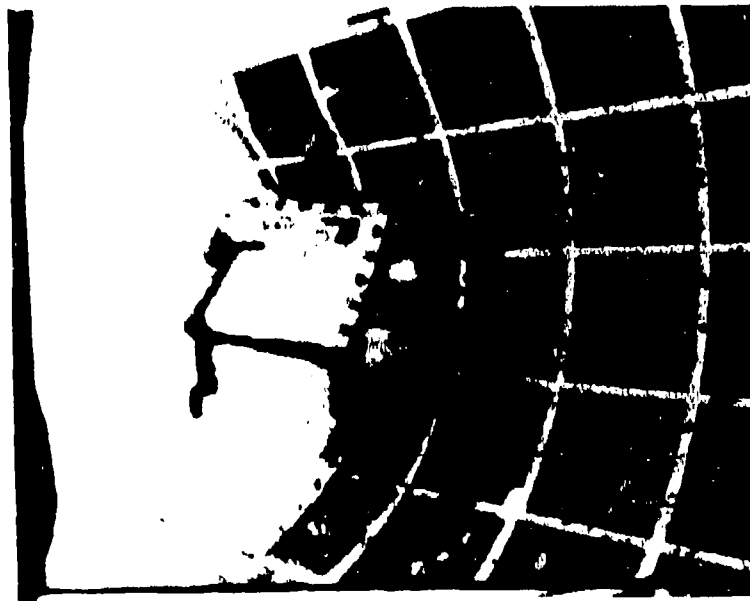
FIGURE 36. High-Speed Film of Hydraulic Ram Damage Occuring.

FIGURE 36. (Contd.)

The second panel tested contained the grid of Kevlar cords. The 23-mm API projectile struck the panel near dead center, causing extreme damage (Figure 36). The panel cracked and buckled both vertically and horizontally from the point of impact. The cracks extended to three of the four edges of the panel. The upper right quarter of the panel was held to the rest of the panel only by the Kevlar cords extending down to the lower right quarter (Figure 37). Nearly three quarters of the panel delaminated. Due to the loss of all structural value, this panel was classified as a drastic failure. Both the cracking and delamination extended through the severe rating zone.

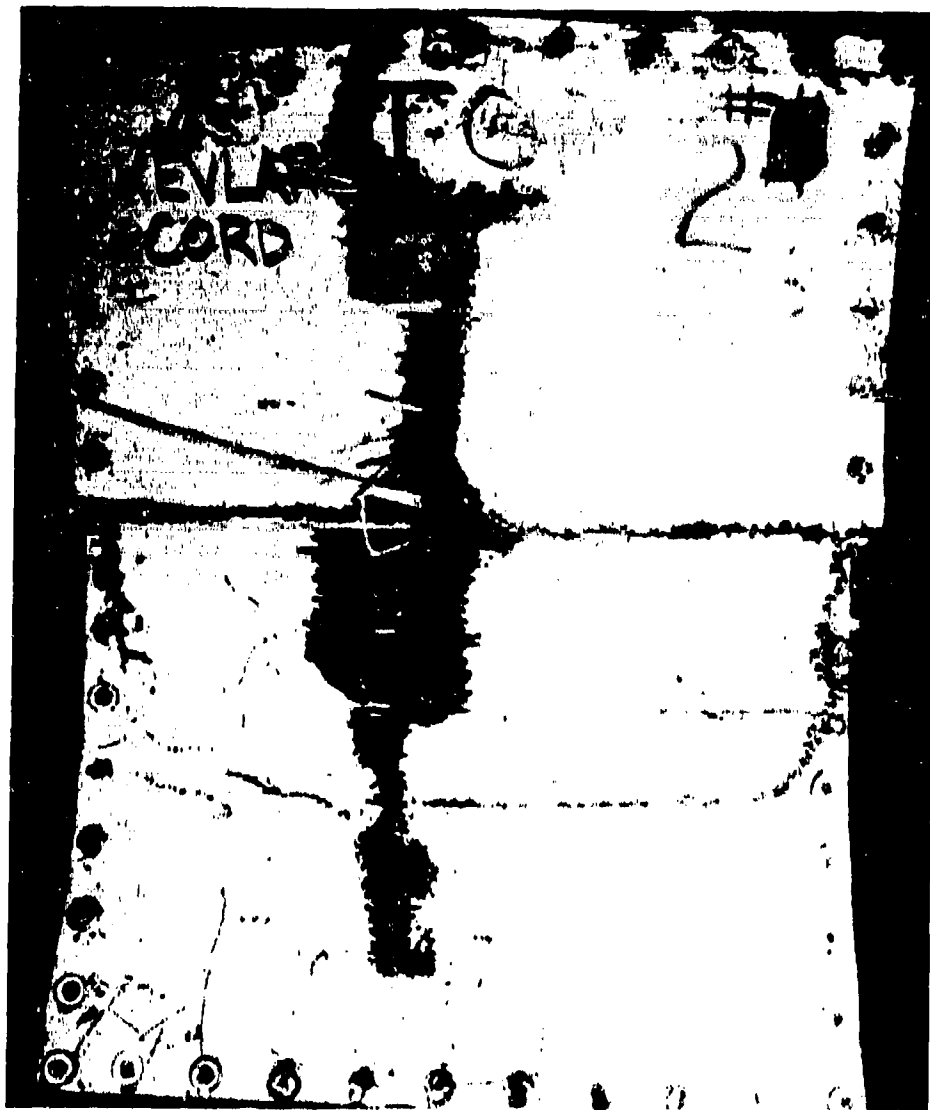
FIGURE 37. Damage Sustained by Kevlar Cord Grid Panel
Subjected to Hydraulic Ram From 23-mm API Round.

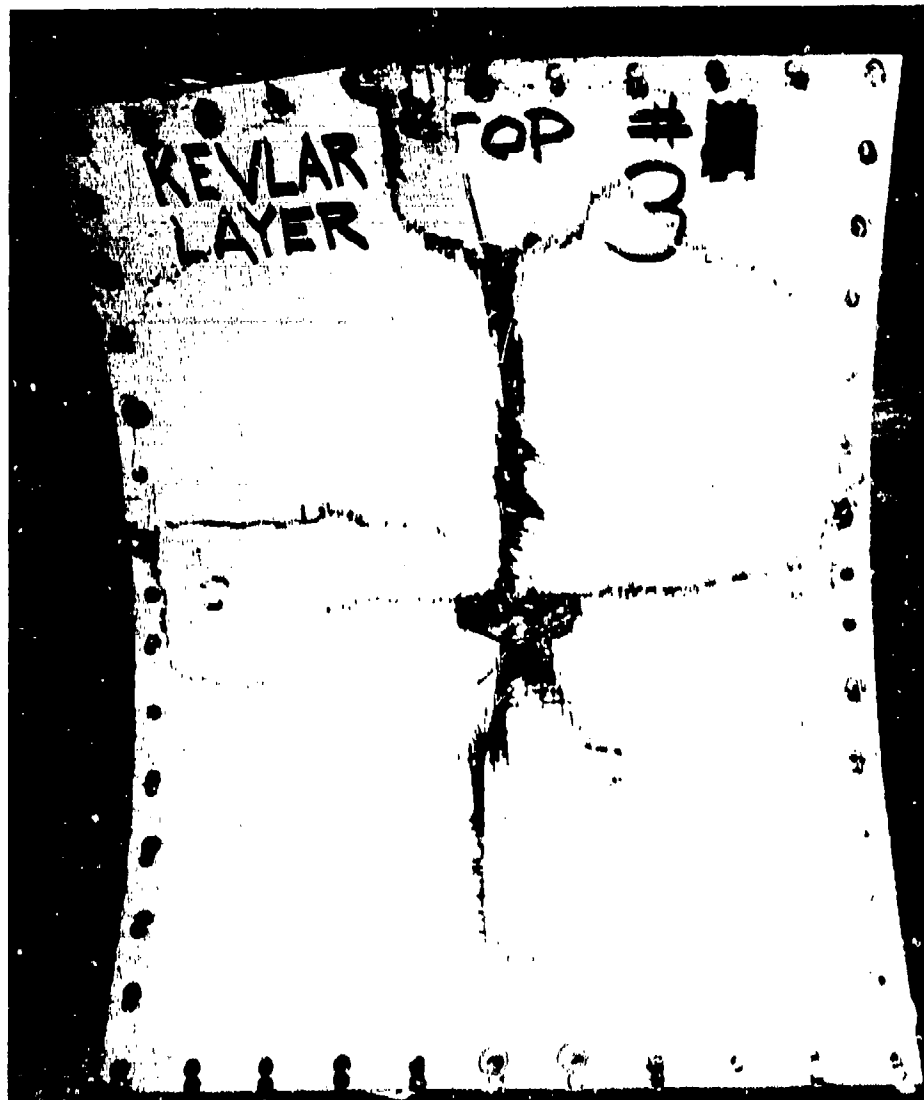
FIGURE 38. Damage Sustained by Kevlar Layer Panel
Subjected to Hydraulic Ram From 23-mm API Round.

The third panel contained a layer of Kevlar fabric. It was also shot with a 23-mm API round that struck the center of the panel, and like panel No. 2 caused the panel to crack and buckle horizontally and vertically from the point of impact (Figure 38). The cracks on panel No. 3 only reached two edges. The lengths of the cracks were long enough to reach the severe damage zone. Delamination was contained within the minor zone, except for one small area that extended into the moderate damage zone. As was the case on the baseline panel, the adhesively bonded stiffeners were blown off of the panel by the hydraulic ram. The overall rating of panel No. 3 would be severe damage.
